## Replacing the Speed Control Quadrant Roll Pin with a Bolt, 2 Star washers and a Nylock Nut

*Originally Written by Bill Mayo (See June 13 2016 Update from Bill at the end)*

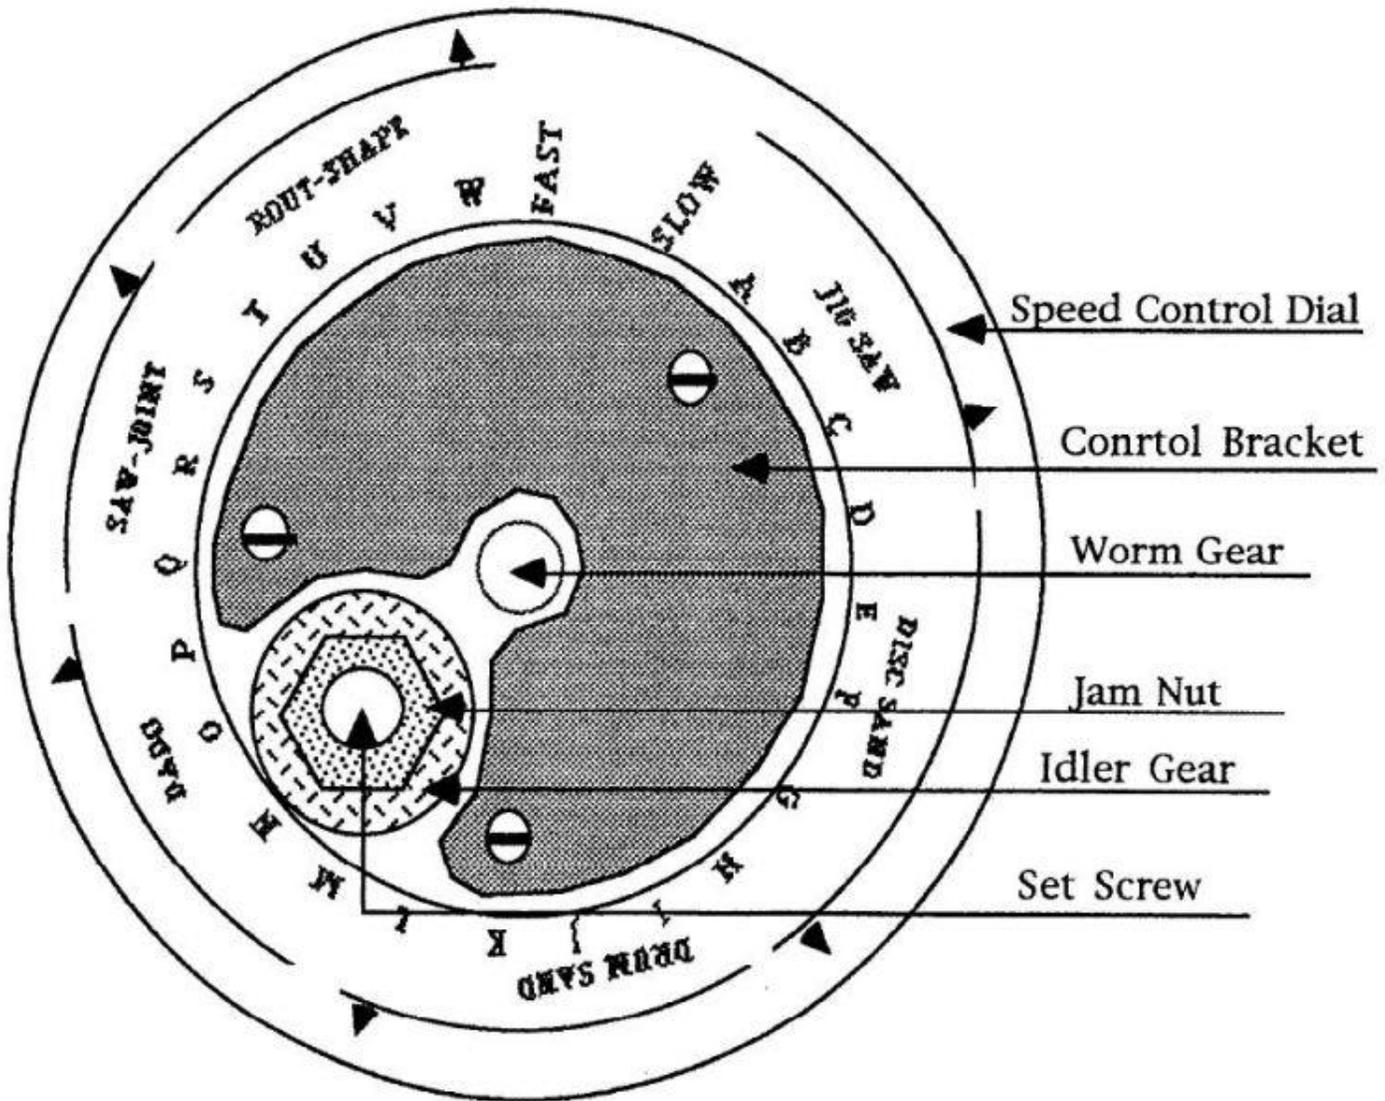
I find about 50% of the headstocks I rebuild need the quadrant replaced. I have spent a lot of time trying various fixes/modifications/solutions for this problem. [The major problem is that owners do not lubricate the Control Sheave causing it to slightly bind/stick on the Idler Shaft.](#)

[Most customers turn the handle too fast which causes the Speed Control leg to deform/bend allowing the worn gear to operate on the side of quadrant teeth slowly destroying the teeth.](#)

This problem results from the quadrant slowly bending the Speed Control bracket leg which causes the quadrant roll pin to wear the holes bigger in the legs of the speed control bracket.

This causes the quadrant to tilt and is no longer centered on the control sheave bearing button. This causes the side of the quadrant teeth to wear quickly as they are no longer centered on the steel worm control gear of the Speed Control Assy.

I quickly found that allen head 10 32 X 2 1/2" bolt fits in the quadrant and legs without any drilling or shimming required.

The star washers was added on the outside of the legs after a year as I found the bolt would start turning in the legs when I want all the rotation to be the quadrant on the bolt.

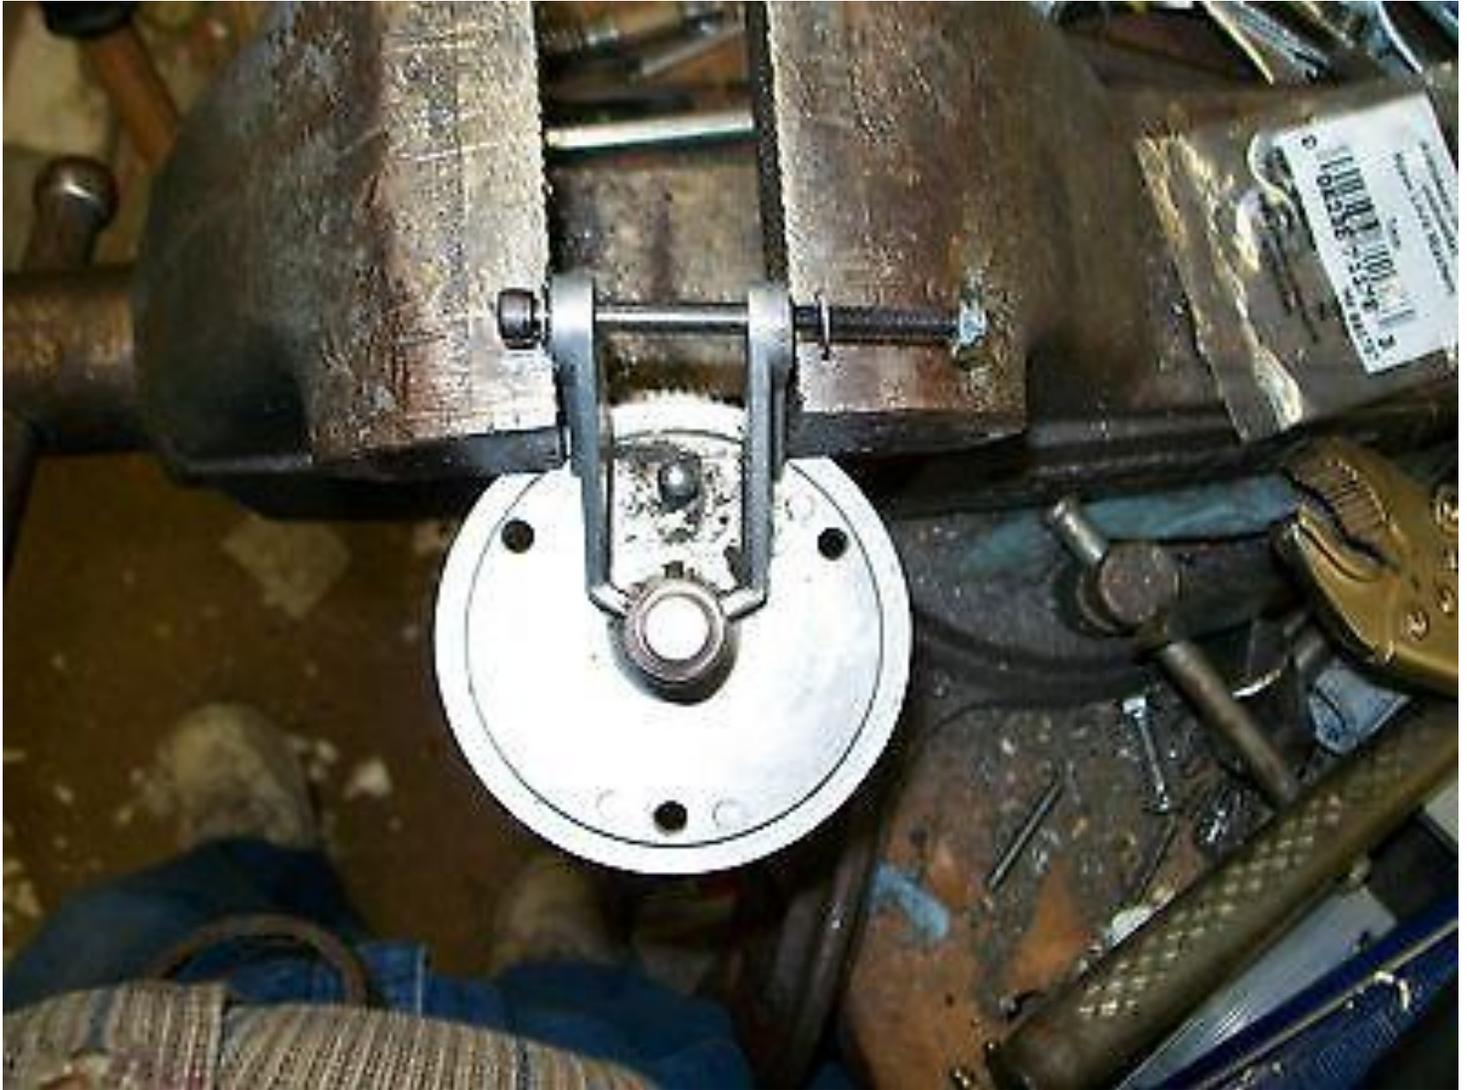
Since the quadrant roll pin wears the holes and the leg bends which causes the quadrant teeth to wear only on the teeth edges, it may jam or make changing the speed quite hard.

The one leg is bending on the speed control bracket.

I put a little wheel bearing grease in the quadrant hole and use an allen wrench to thread the bolt through the legs and quadrant.

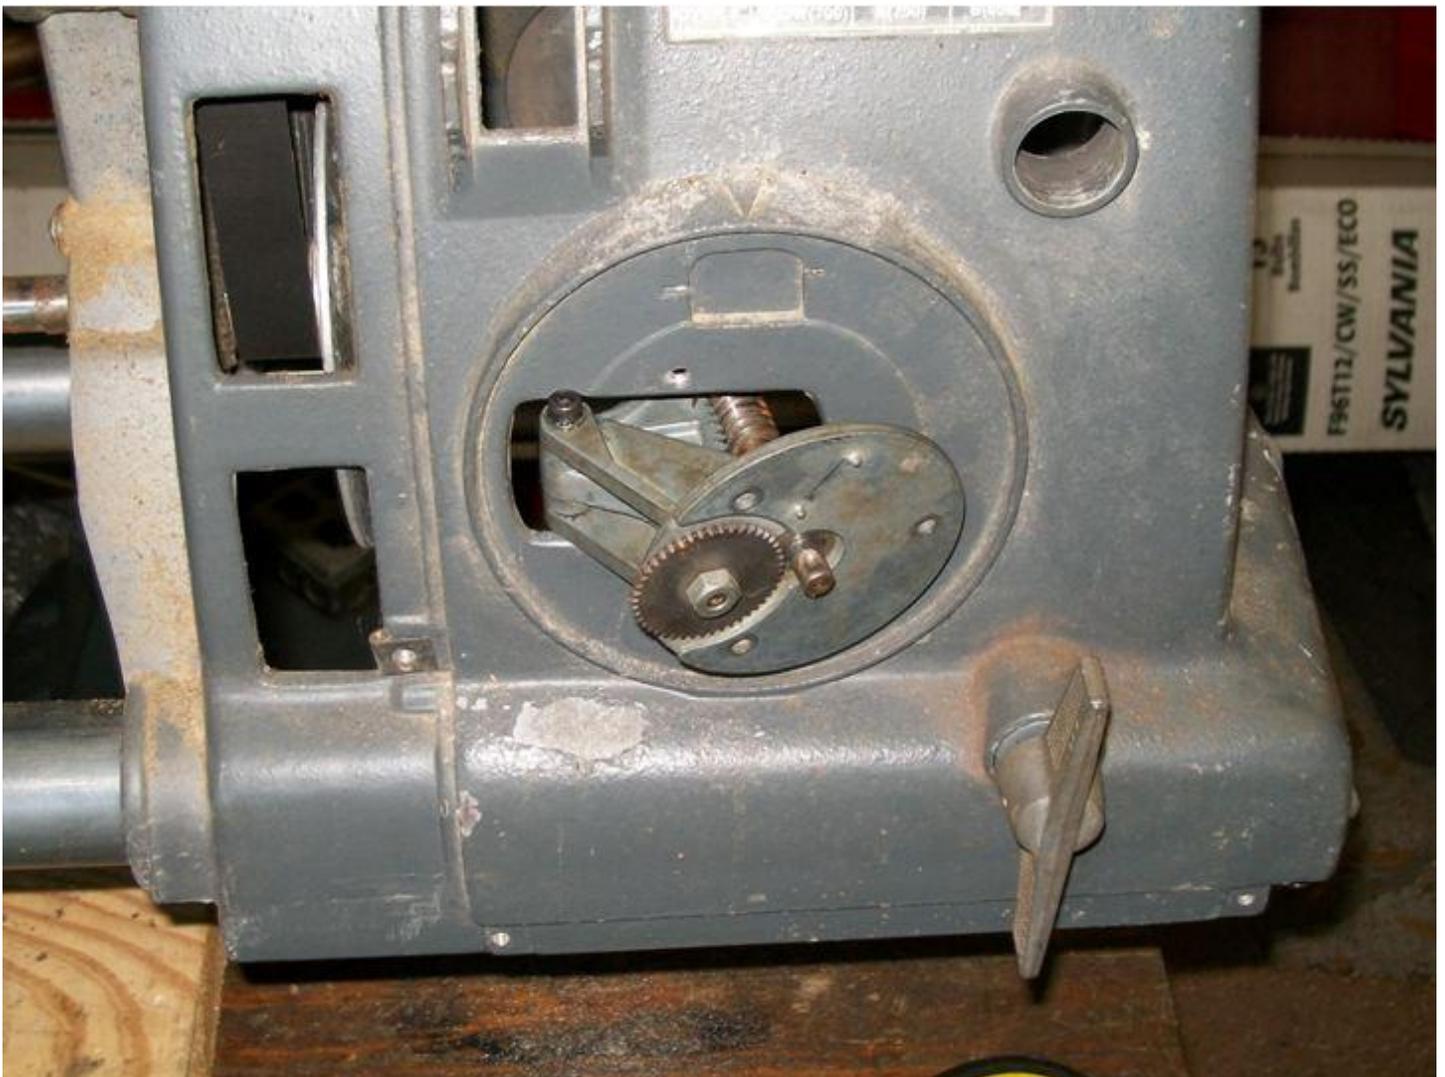
Headstocks with a small speed control assembly horizontal hole will need a small slot filed for the allen bolt head to clear when installing.

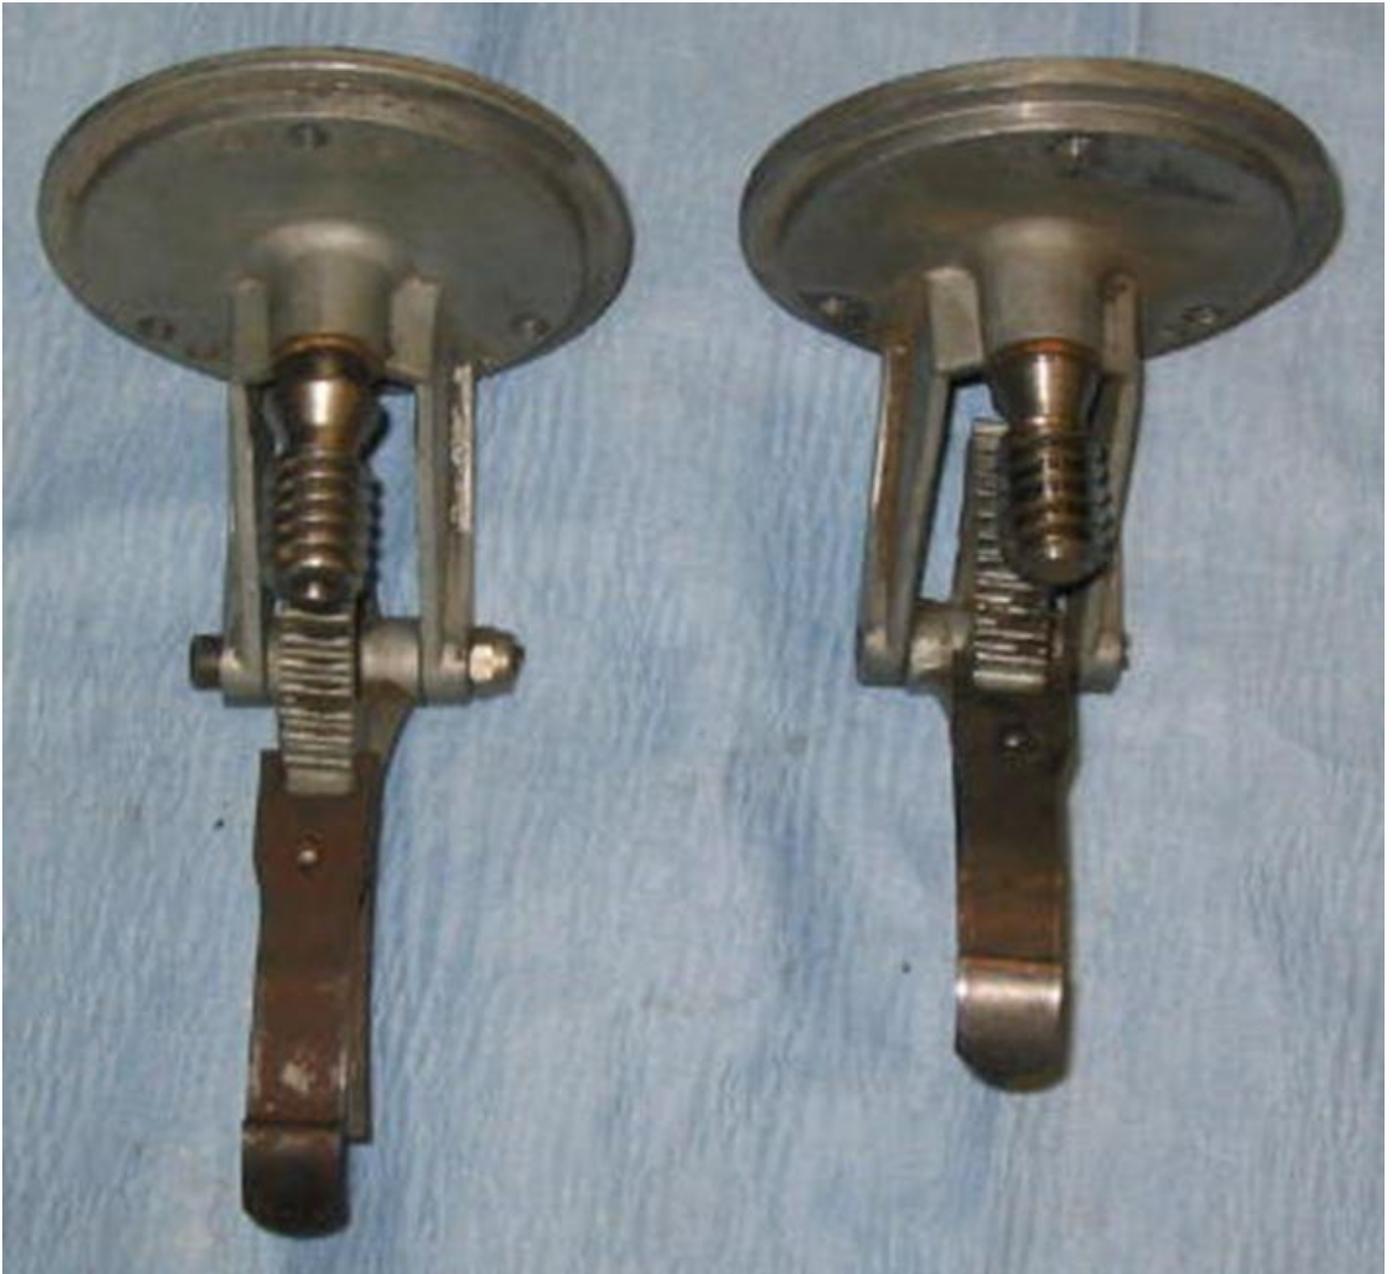
This picture shows the removed Speed Control Assembly on the right side and a rebuilt Speed Control Assembly on the left side.

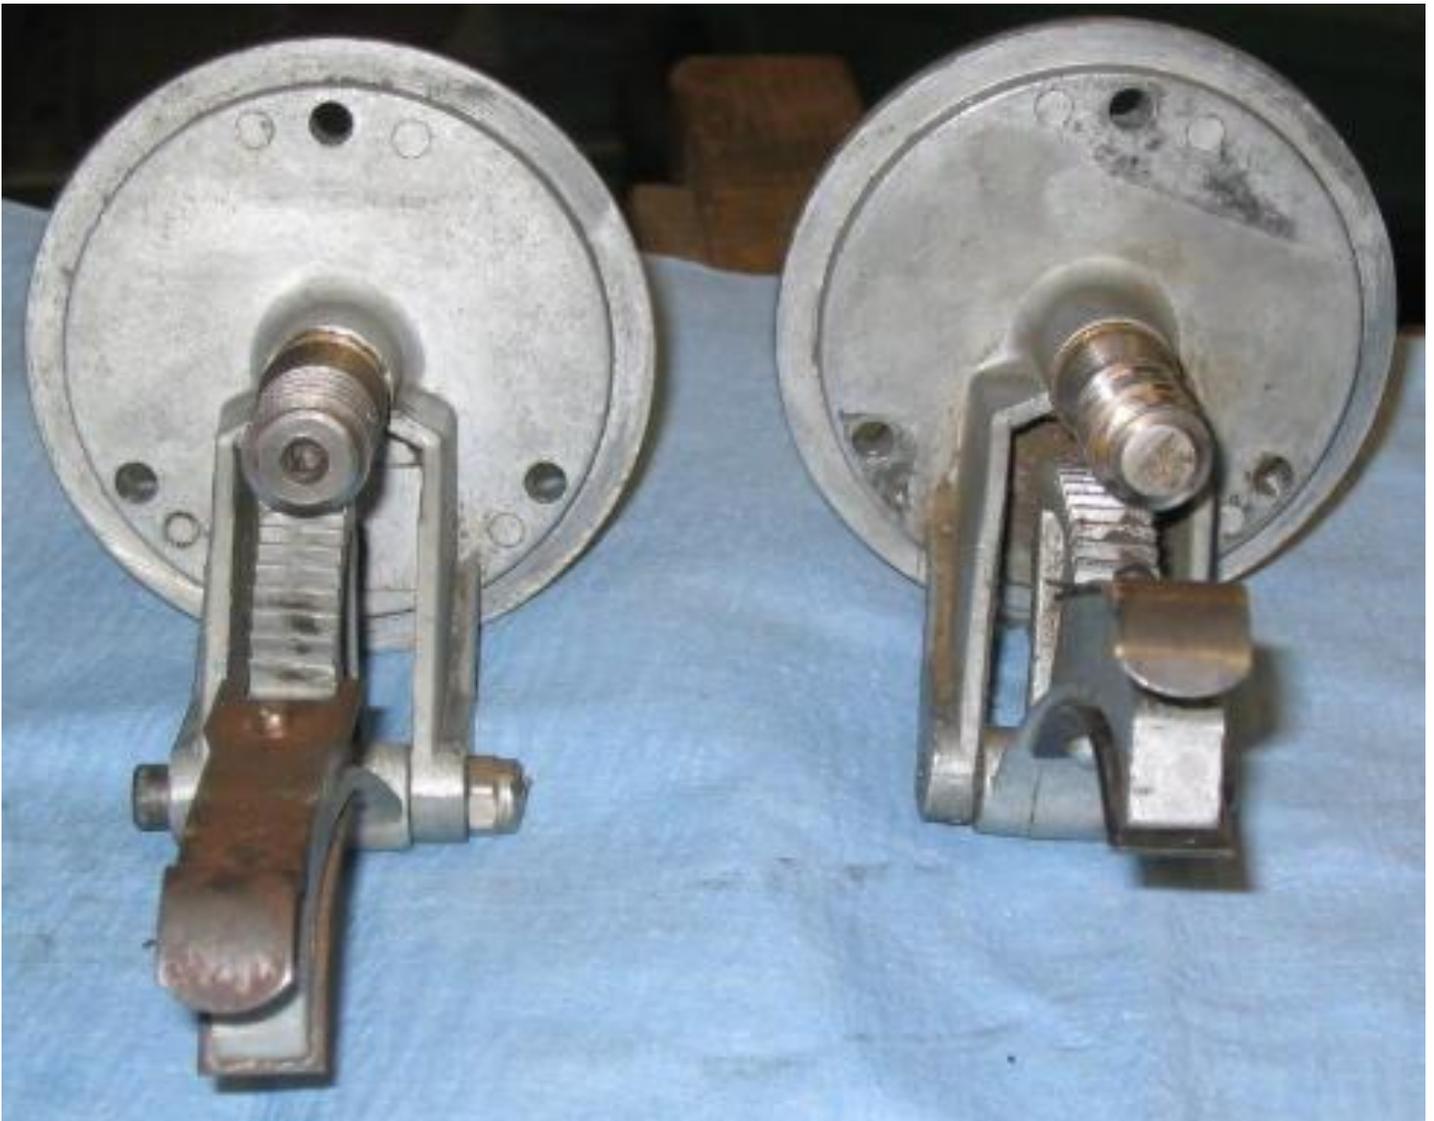
The left side one shows the remaining threads on the bolt was [hack sawed off](#).

I file the end of the bolt to remove any sharp points after hack sawing the bolt.

Additionally, with regard to cutting off the bolt in the Speed Control described above, he now offers the following suggestion: *The longer bolt can be left sticking upward and the ON/OFF switch wires routed behind the bolt and/or a nylon clamp can be installed on the bolt to hold these wires to replace the nylon clamp (which gets lost most times).*

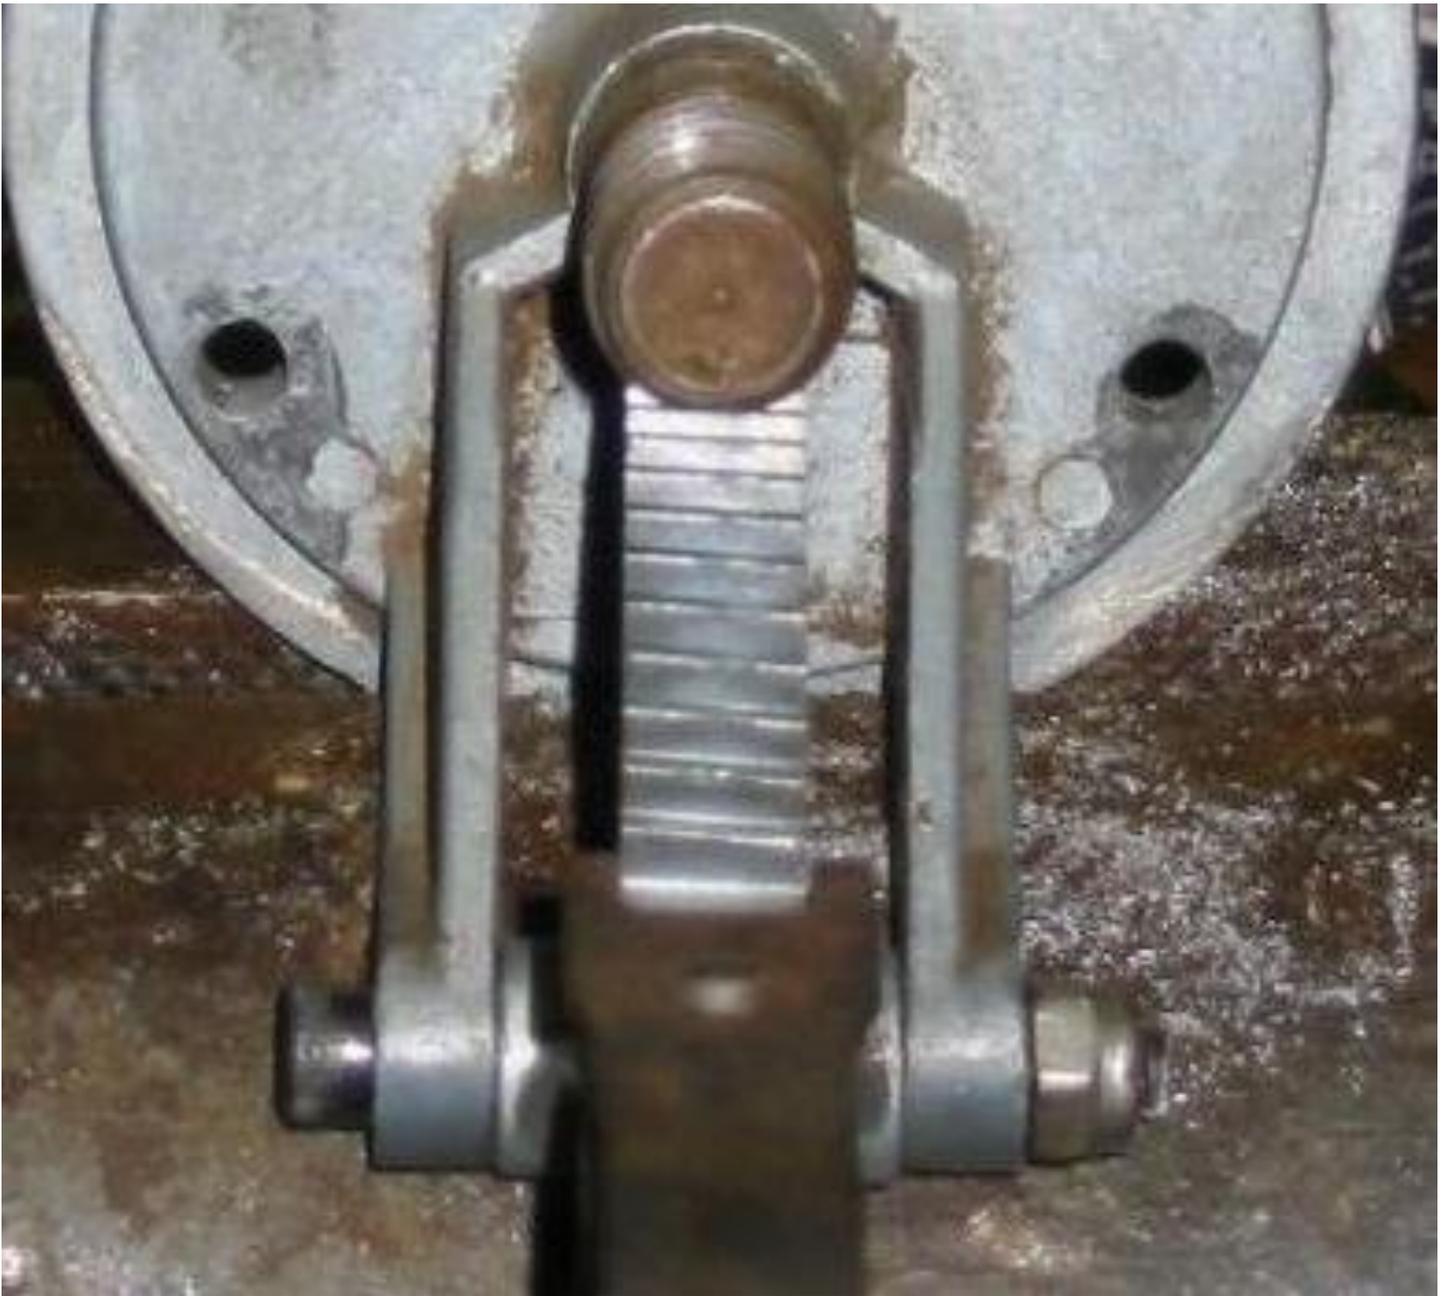
Note that the worm control shaft is in the **center** of quadrant teeth.

One of my secrets is I actually use a hammer and punch with the bracket in a metal vise and tap/hit the bent leg **(no quadrant installed)** toward the center.

Most times I have to do both legs to center the quadrant.

I just check that it will still fit between the legs when doing this task until the legs allow the quadrant teeth to be centered in the worm gear.

**The legs bend quite easily**, so it does not take much to realign the legs so the quadrant tracks in the center of the worm gear.

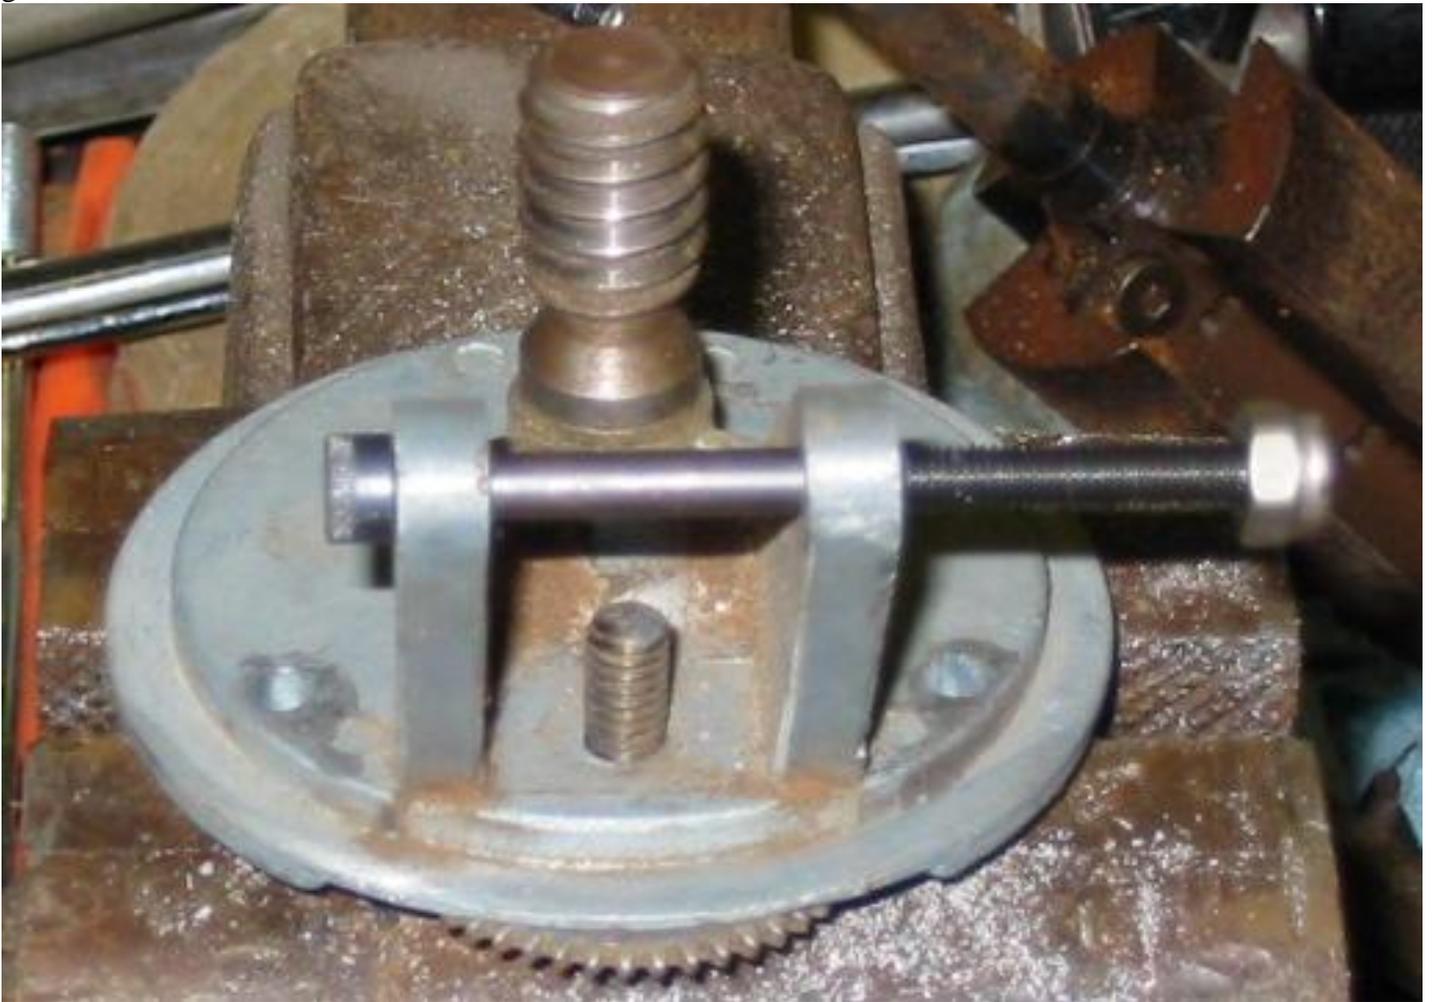
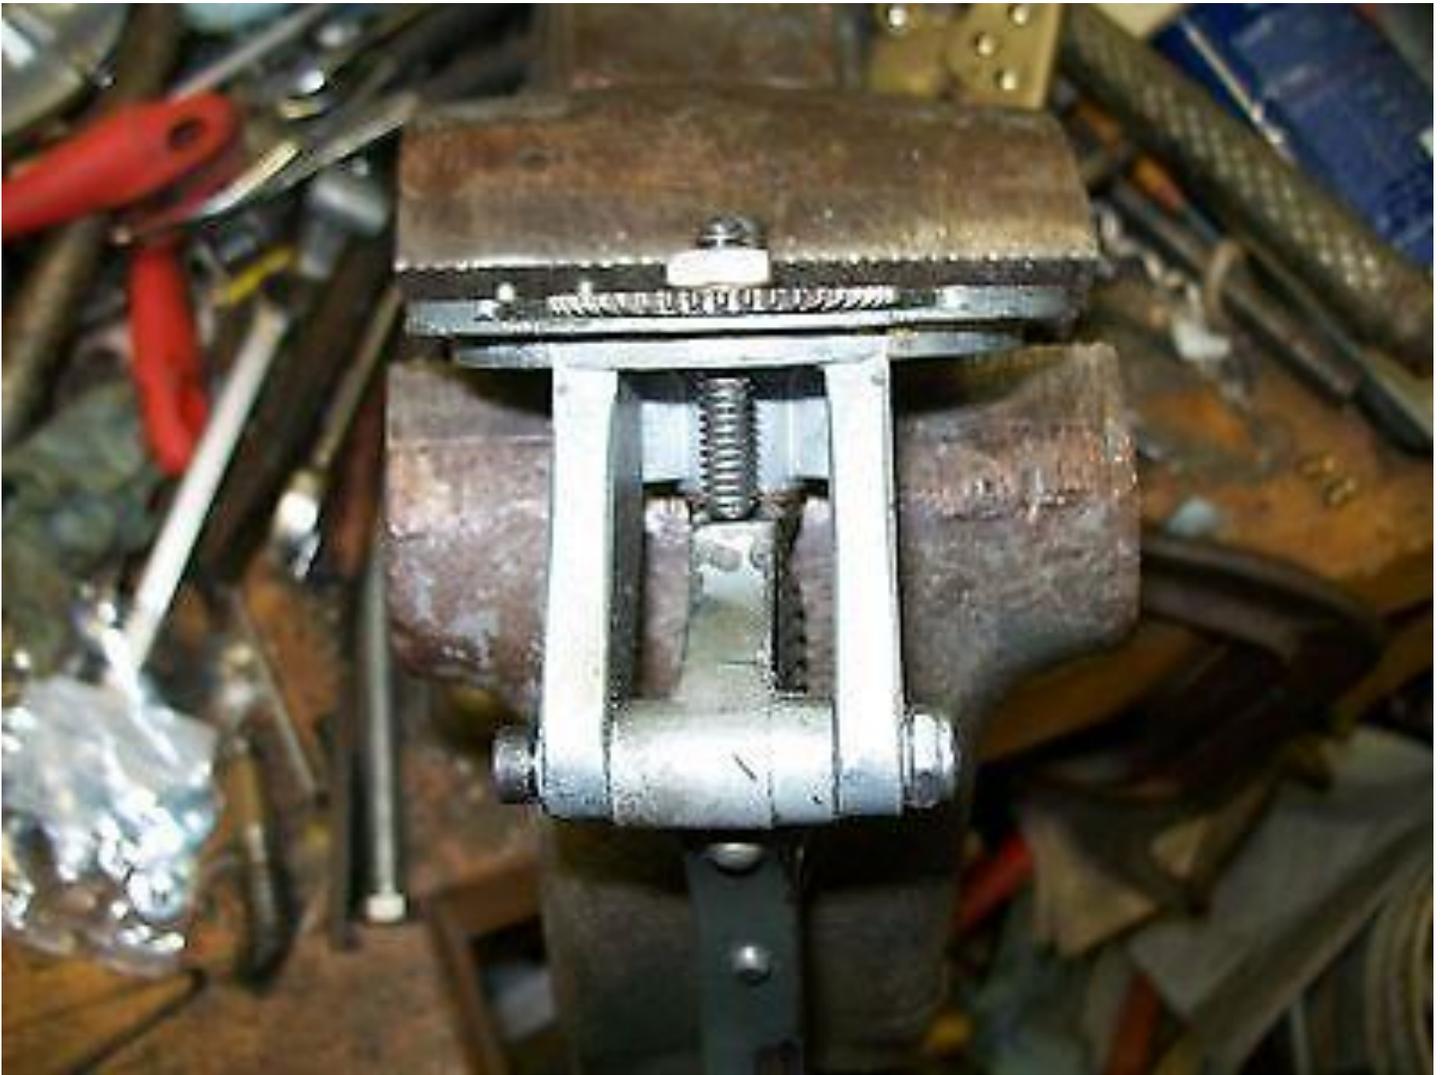
I set the speed control assembly to the FAST position. I rotate the worm gear until the quadrant contacts the high speed adjustment screw. I check where the indent in the worm gear shaft for the speed control handle is at this time.

Then I will adjust the screw CW (nut loose) until I can get the indent to stop at the 11:30 position and tighten the nut. It should never take more than a one turn of the screw to do this. I leave the belt off when installing the speed control assembly.

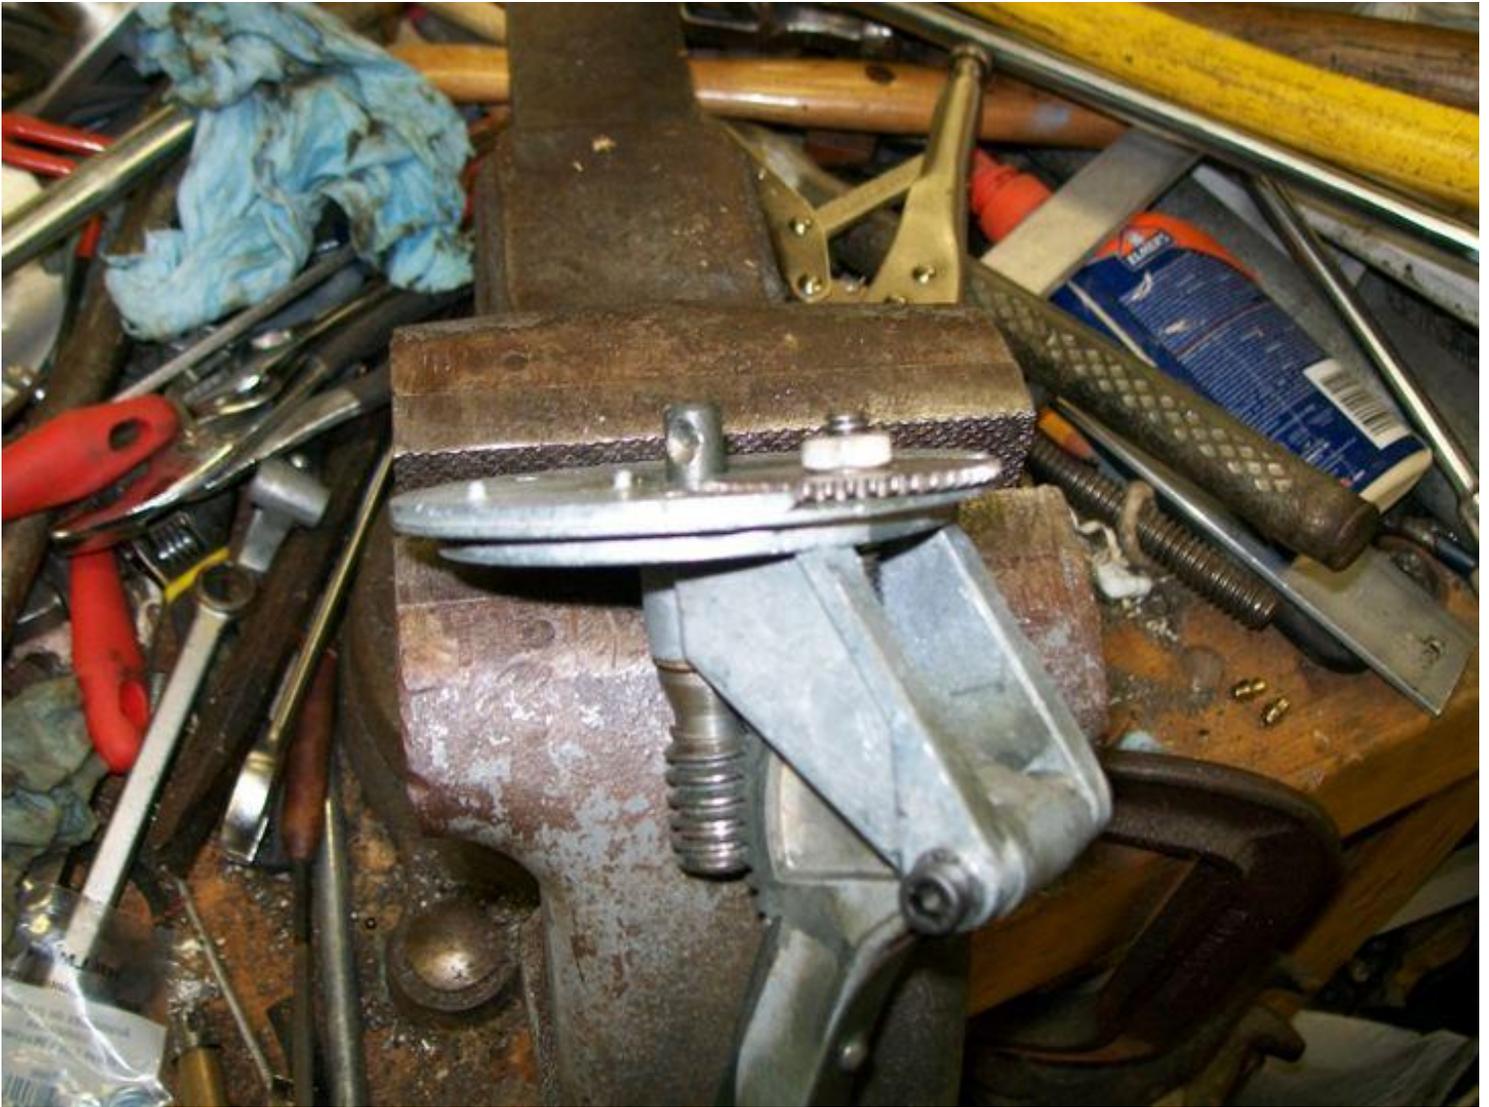
If you have the thin locking nut of the high speed adjustment screw, I want the screw head to be extending about the width of the nut pass the nut to start.

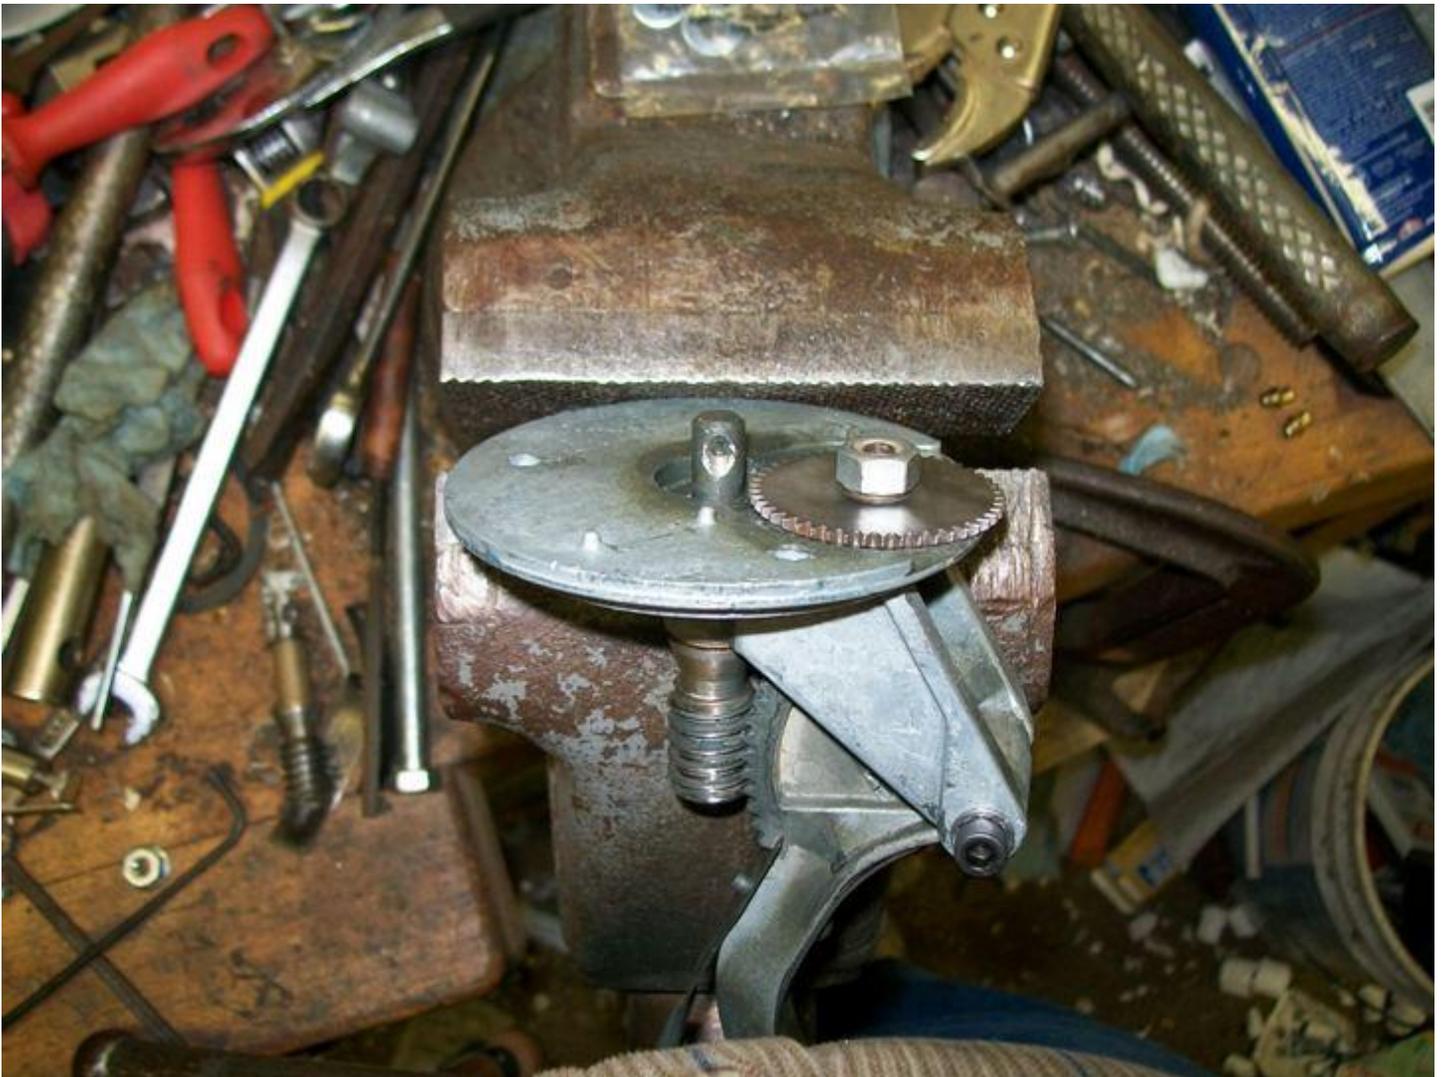
If a regular nut, I set the screw even with the outside of the nut to start.

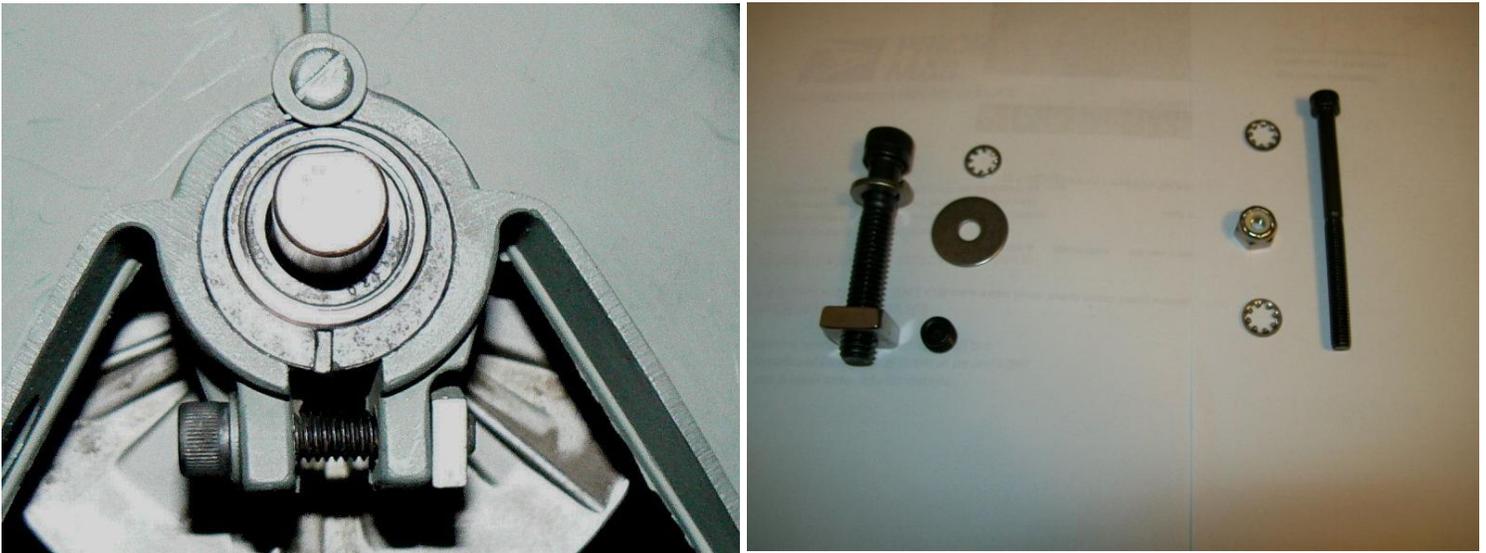
10-24 x 2 ½" allen head screw, 2 star washers and a nylock nut for the speed control upgrade, coupled with a #10 X 3/4" body washer & #10 star washer, to better retain the eccentric (12 o'clock in left photo), and a 5/16" X 2" allen head bolt with lock washer and square nut. This replaces the eccentric bushing bolt. *He notes that in 'A' series headstocks, you will have to drill a larger access hole in the side of the "A" (earliest) headstock casing to insert the bolt. B and C headstocks came standard with a larger hole.*

**Word of caution here:** it is possible to over tighten either the existing or the replacement bolt and break off one of the aluminum ears casted in the headstock just below the eccentric. Use caution. By the time you have compressed the lock washer in Bill's kit to where it is flat, it's likely tight enough.
